**PROJECT OVERVIEW**

**LOVE, MAR VISTA MURAL**

Today, I'm excited to share a proposal to restore and preserve the LOVE, MARVISTA mural located at the Council Thrift Shop and USPS parking lot, a piece that has become a recognizable landmark and point of pride for the neighborhood.

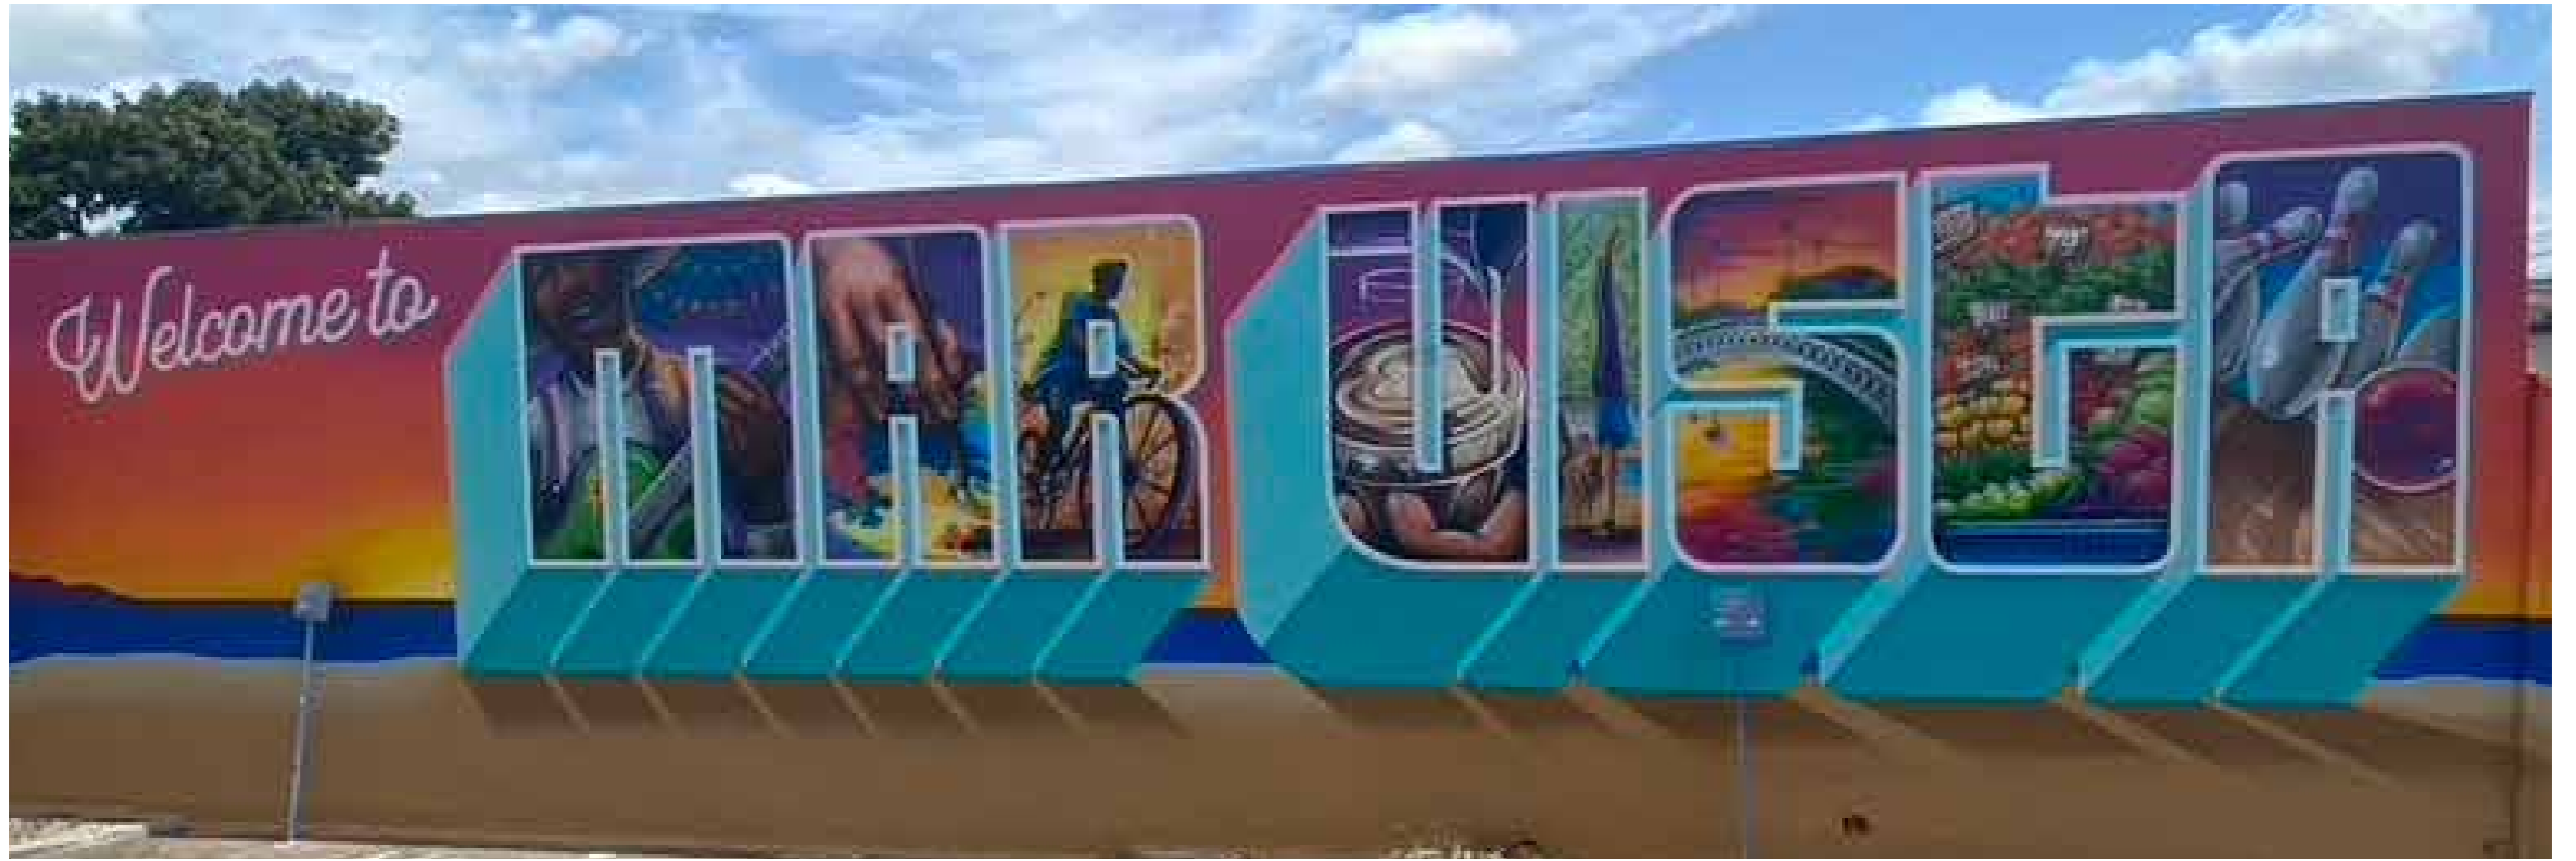
## ORIGINAL MURAL

Completed in April 2021, the LOVE, MAR VISTA mural transformed the Mar Vista Post Office parking lot into a vibrant public landmark for residents and visitors alike.

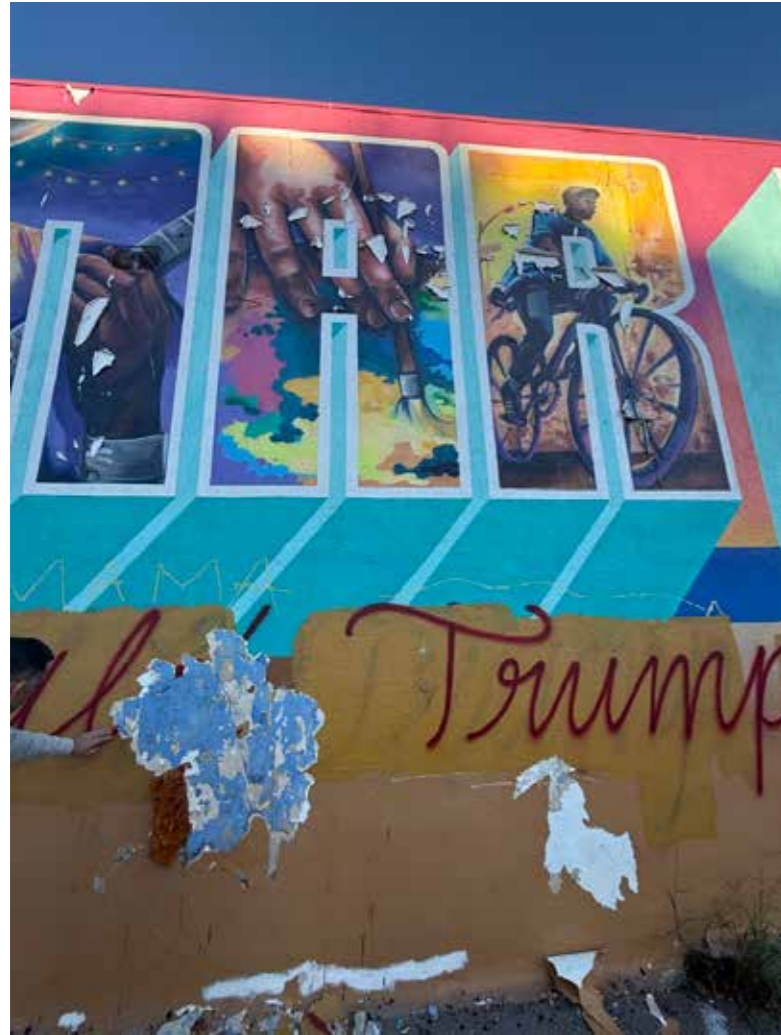
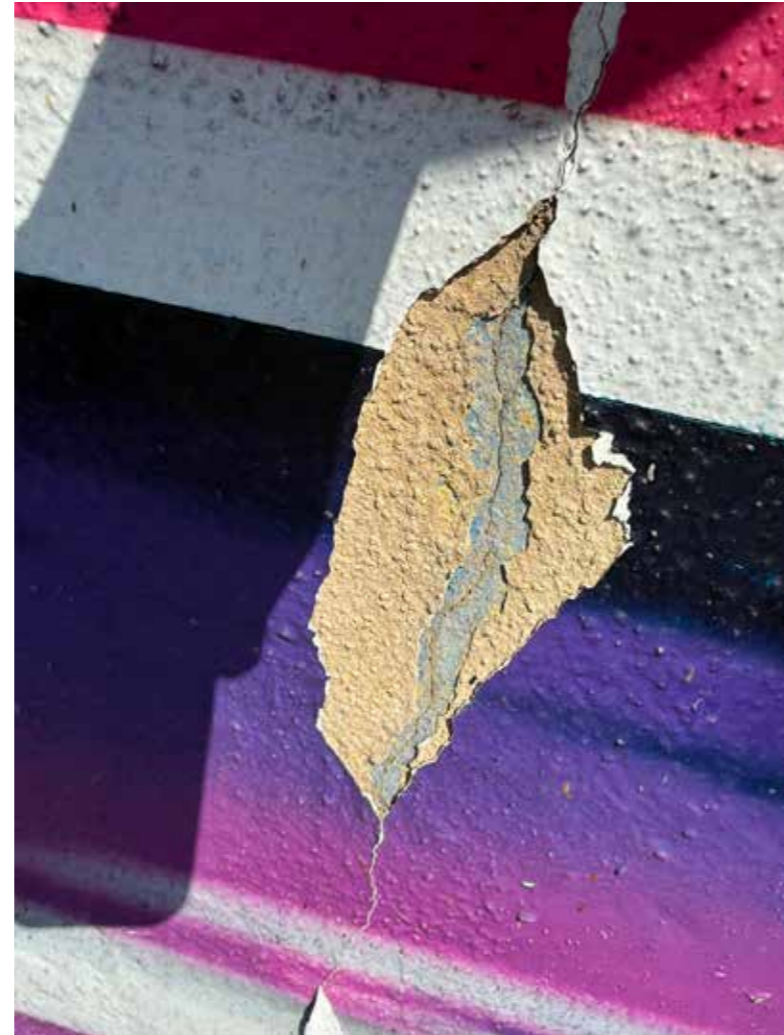
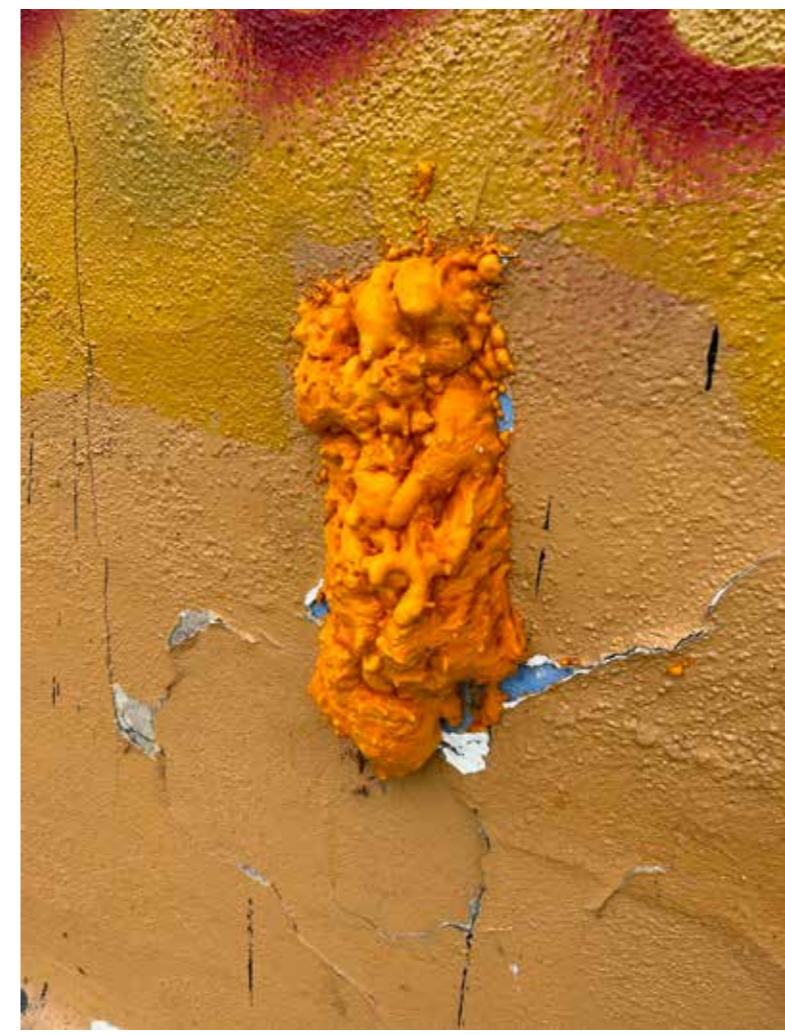
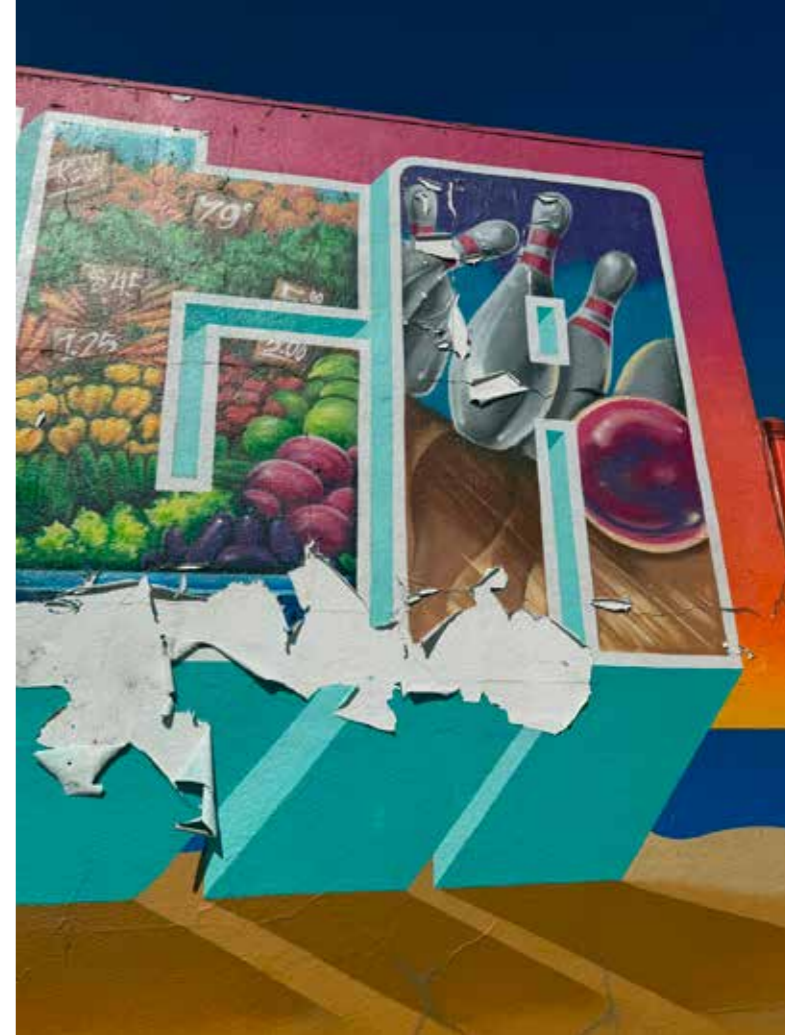
Over time, however, unforeseen structural and environmental issues began impacting the mural's longevity.

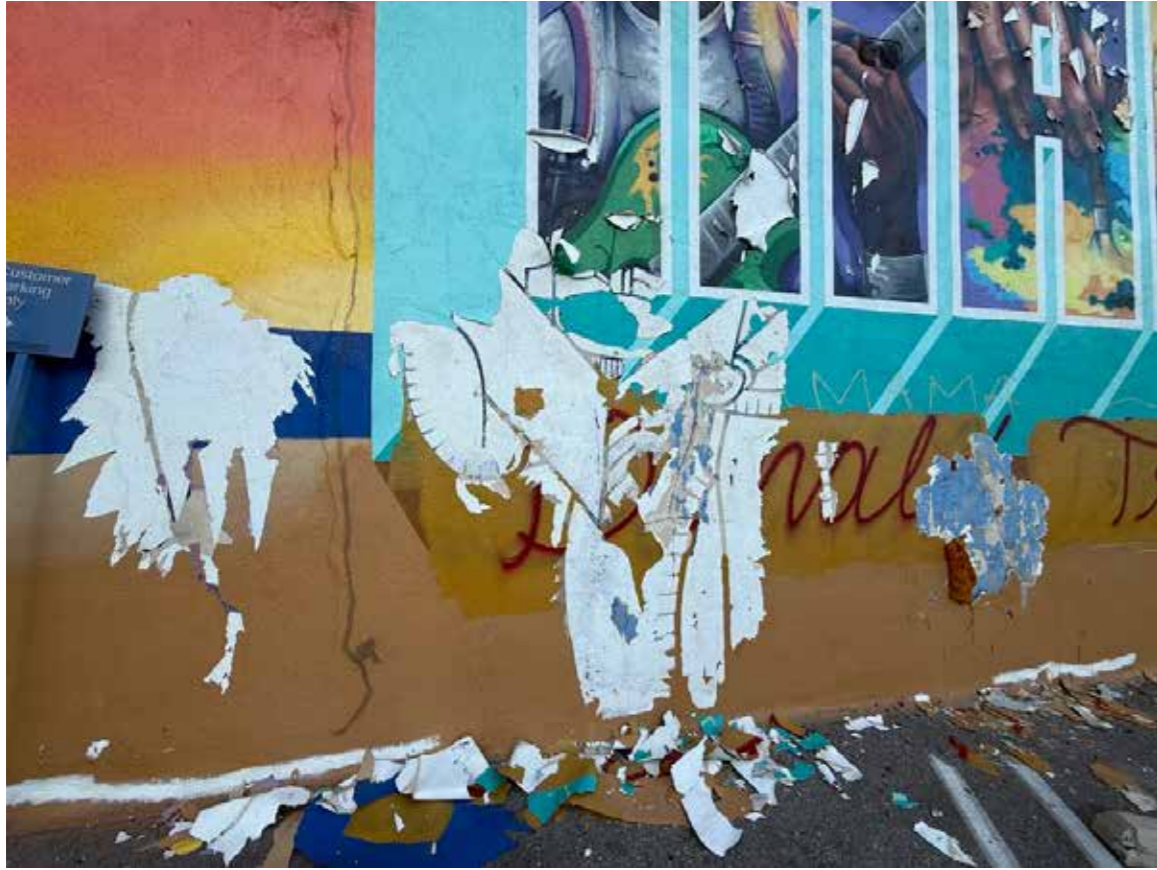
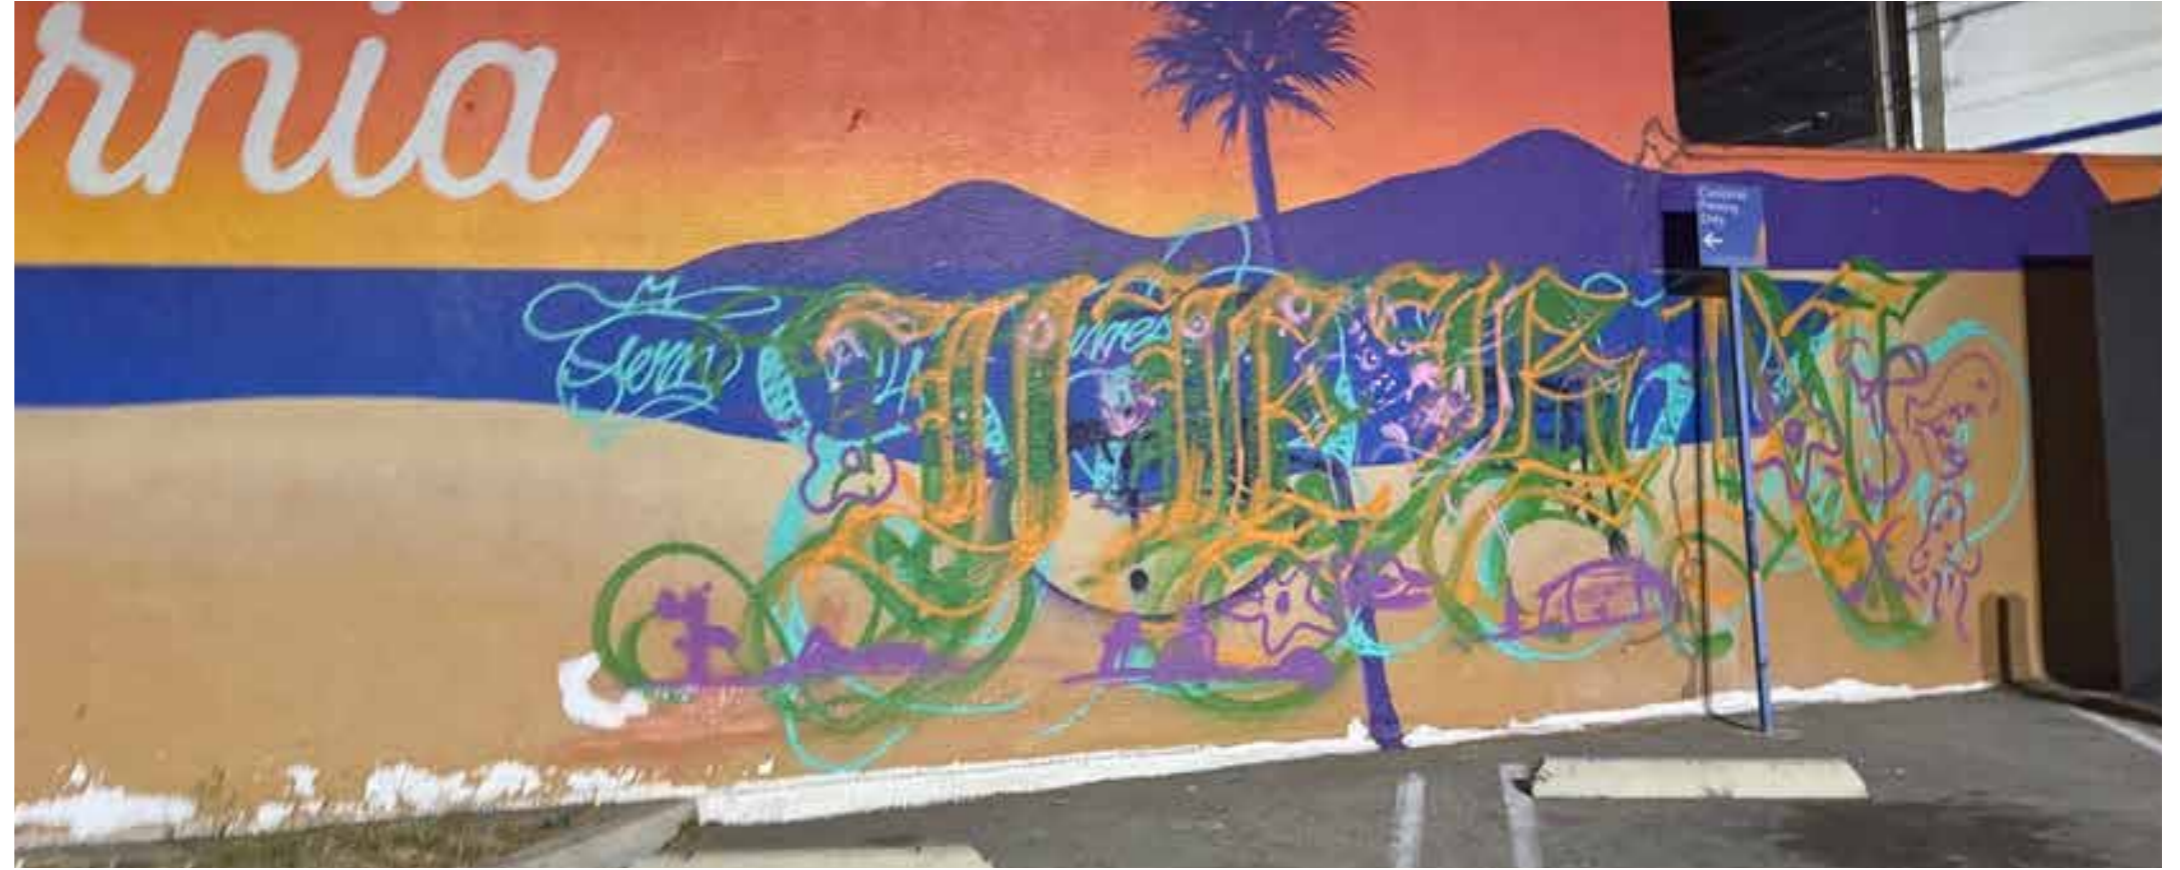
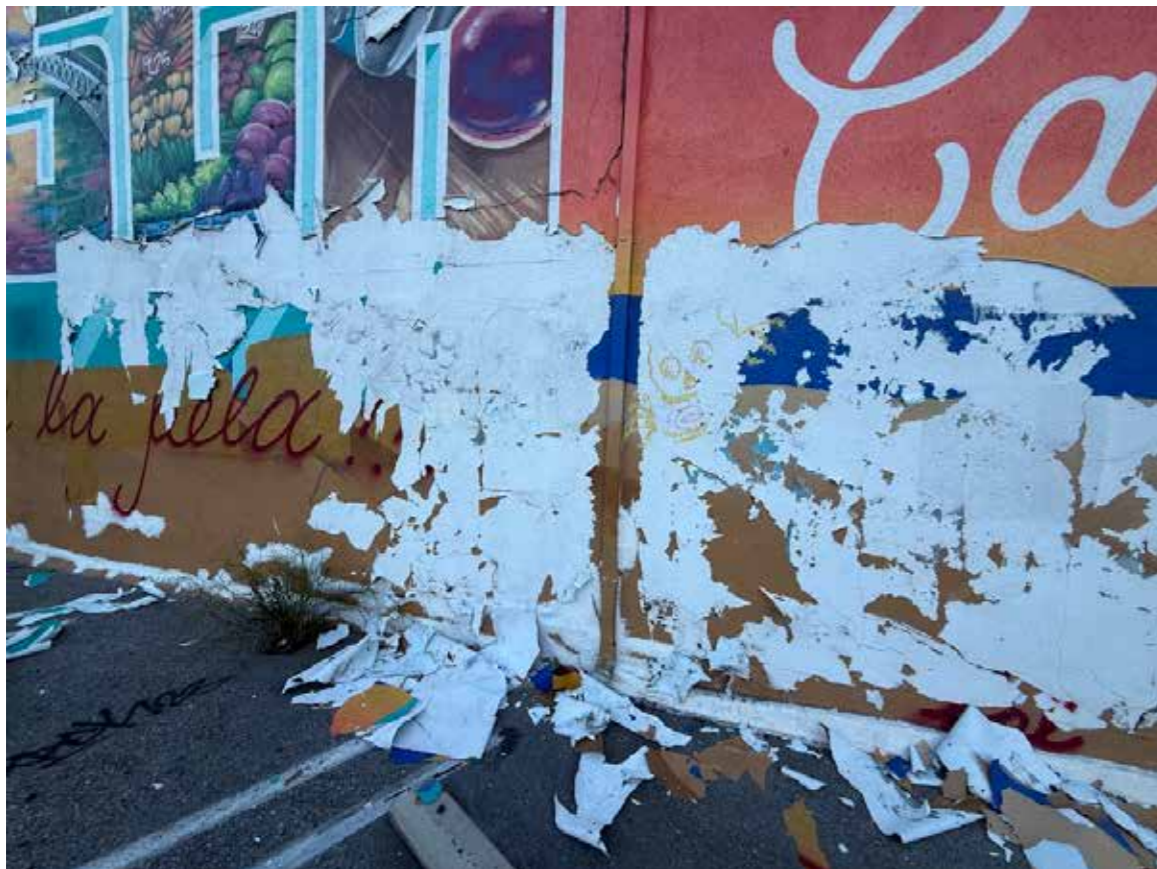
## DAMAGE

Over time, the mural experienced significant deterioration caused by a combination of structural and environmental factors.

Moisture intrusion from roof leaks caused the stucco substrate to crack and separate from the wall surface.

Existing cracks and openings allowed water to penetrate the wall, accelerating peeling, wear, and structural failure across large portions of the mural.

The anti-graffiti coating may have also contributed by trapping moisture beneath the paint layer.

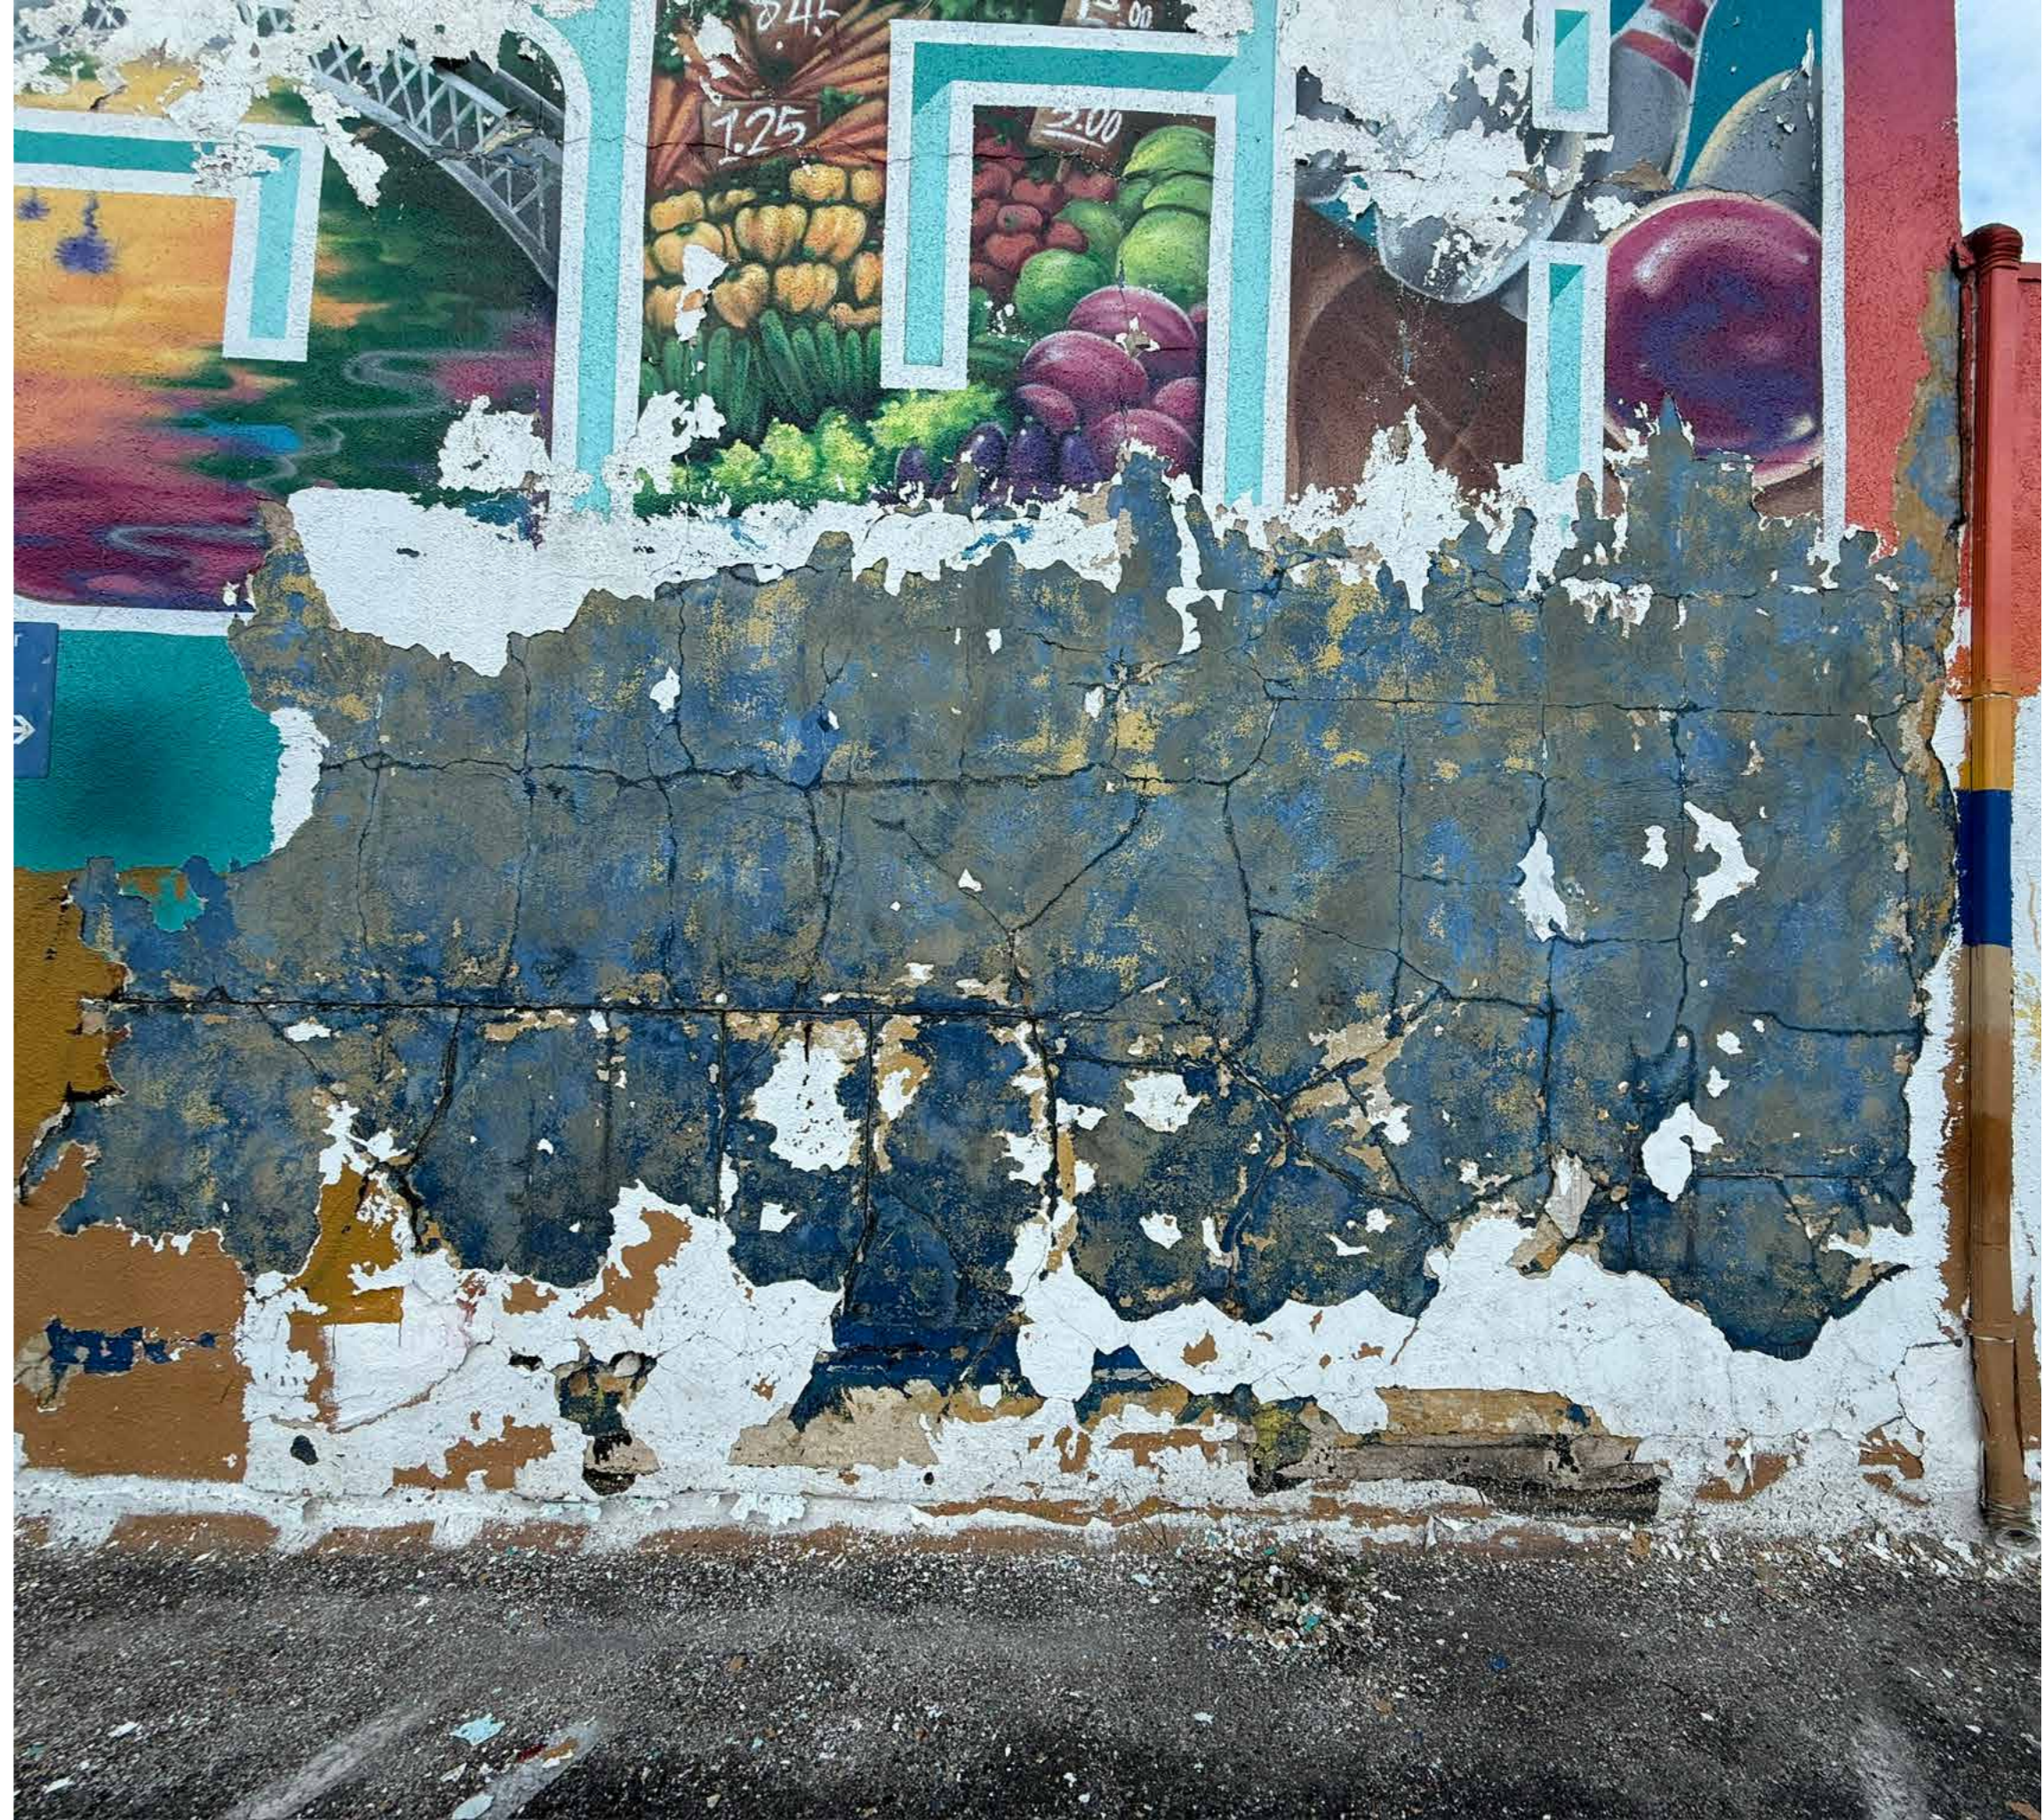
# SURFACE ASSESSMENT

The true condition of the wall only became clear once restoration work began.

During the original budgeting process, the full extent of the substrate damage was impossible to assess prior to pressure washing and removing the failing paint layers.

After weeks of scraping, cleaning, and surface preparation, it became evident that the wall was in far worse condition than anticipated. Large sections of stucco were unstable, with widespread cracking, separation, and material failure throughout the surface.

At that stage, we understood that meaningful restoration would require substantially more labor and materials than originally planned.

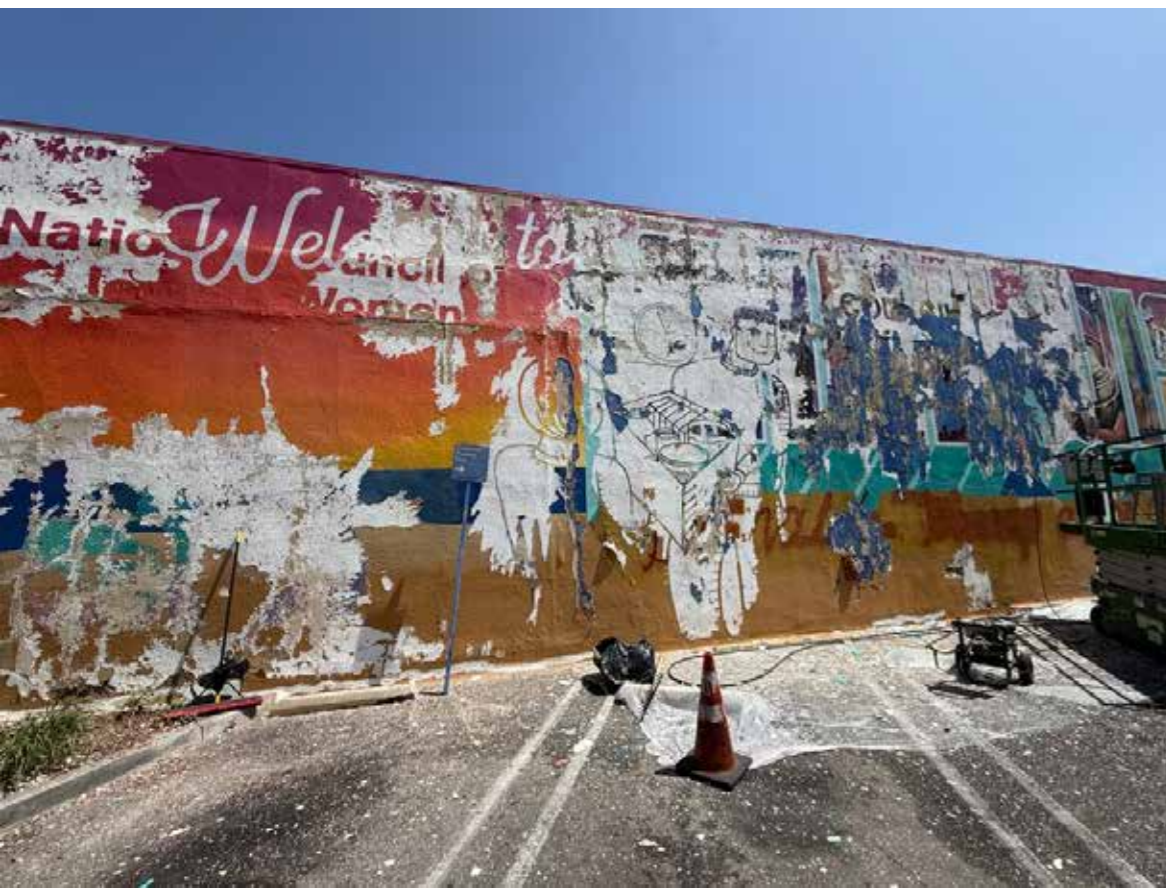
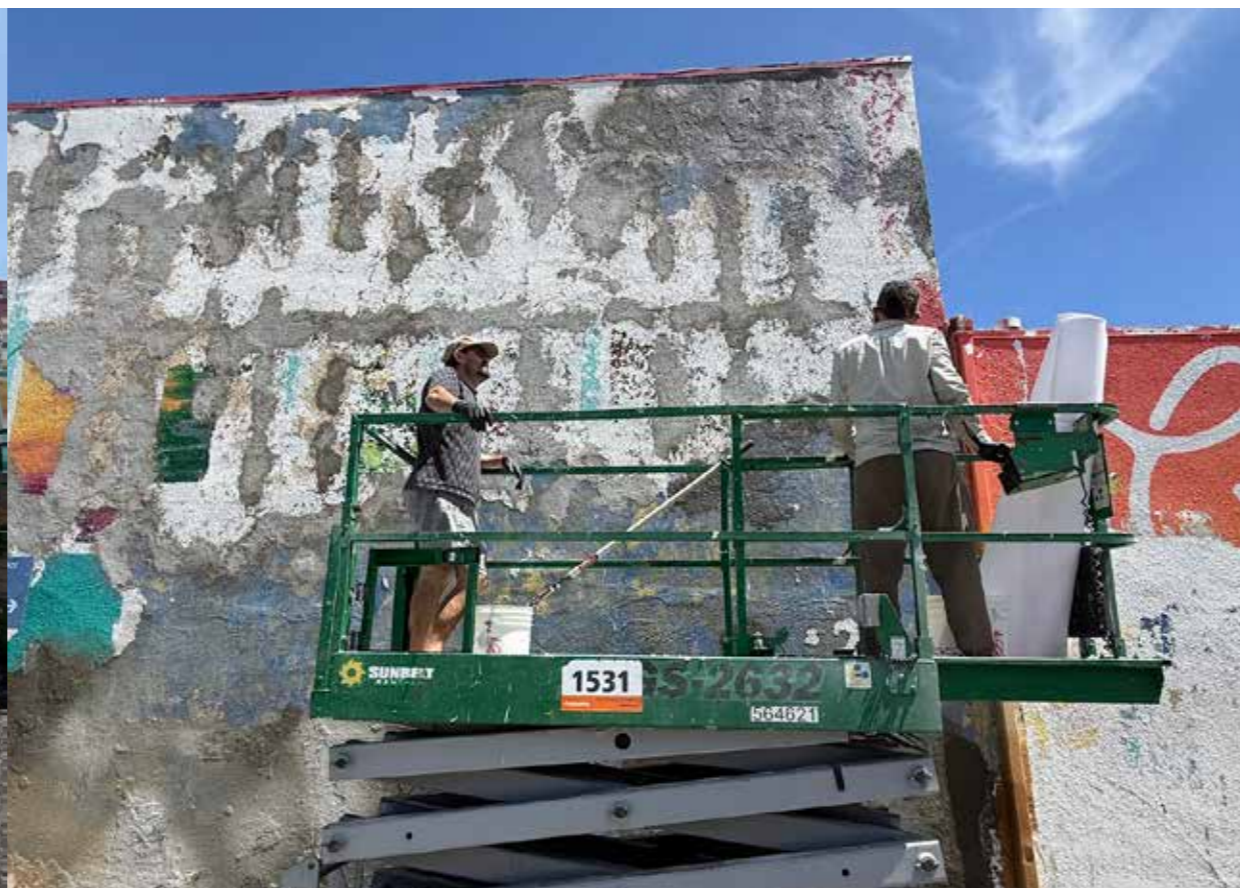
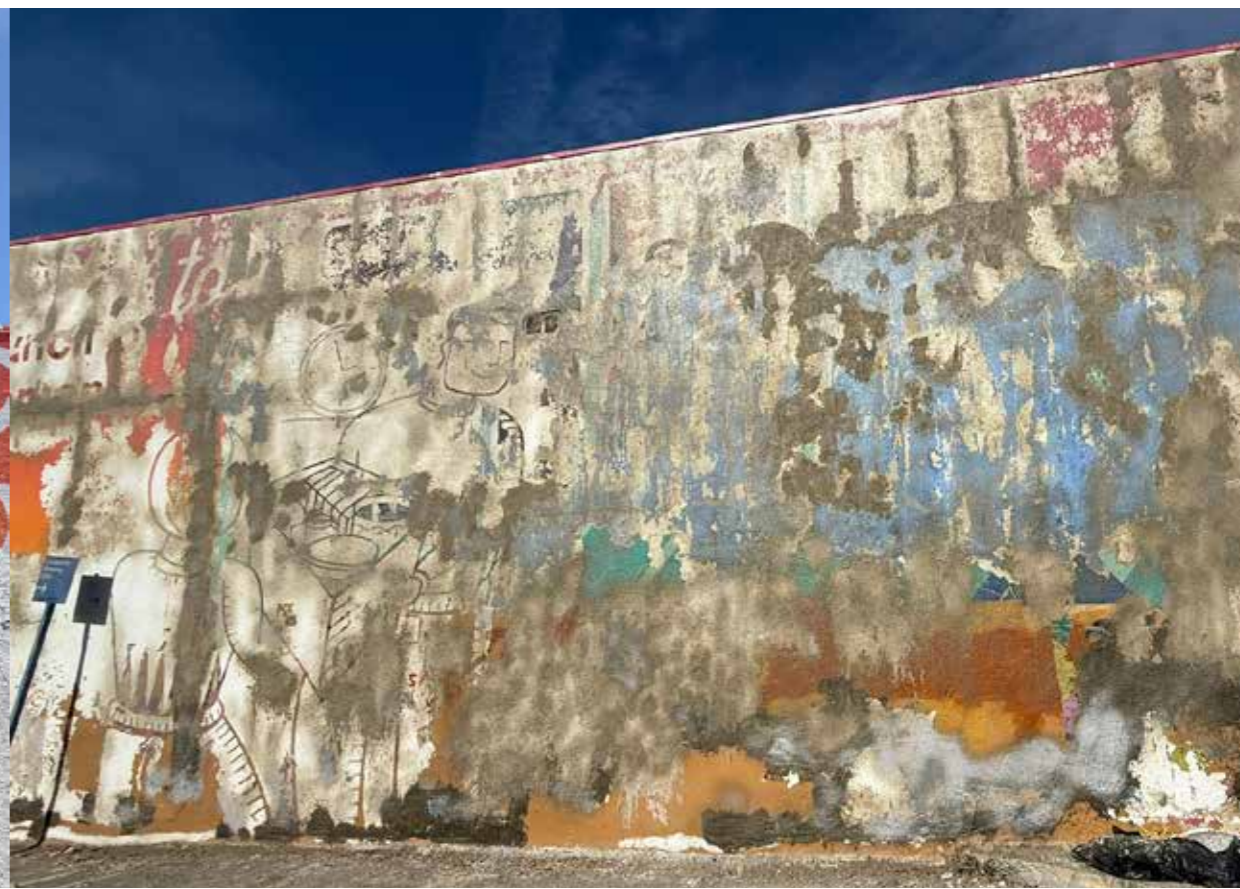
## PATCHING AND RESURFACING

Our priority became stabilizing and protecting the wall to ensure the long-term success of the restoration.

This process included removing failing paint, repairing damaged stucco, patching compromised areas, and resurfacing the wall with a reinforced sealing system designed to improve durability and moisture resistance.

The restoration ultimately required significantly more time, labor, equipment, and materials than originally budgeted. However, completing this foundational work correctly was essential to preventing future failure.
